# ***Warringah Cranes and Transport***

## ***Crane Fleet***

## **Major Inspection Report**

### **Hydraulic Truck Crane**

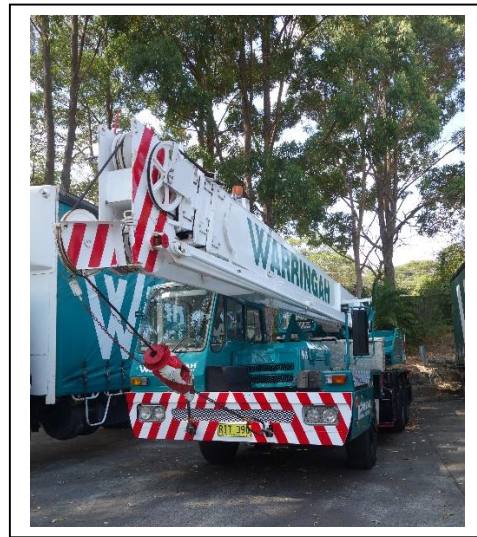
Brand	Kato
Model	NK-250E-III
Capacity	25 ton (3 Axle)
Year	1990
Rego	RIT390 (May 2017)
Last Major Inspection	Nov 2013 25 year Major Rebuild
Hours	11,685
Kilometres	8,851

Underwent full restoration, and extensive rebuild in Nov 2013 (over \$360k spent) and body is as new condition. New Slew Ring and rebuilt hydraulics. Comes complete with full set chains, slings, timbers, along with 2 hooks, and is ready to operate
